Mechanical Failures List

Updated As Of 9/4/2014

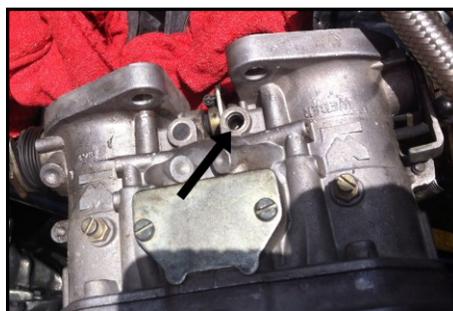
Weber IDF 44 (VW Engine) Fuel Leak - Also IDA & DCOE possibly impacted.

Problem: Factory installed lead plug (filling hole used for machining internal passage) can come out. During a race, the plug came out dumping considerable fuel right on exhaust. A web search revealed that it is not that uncommon. Also documented instance on a Porsche 914. Plug is often inboard and on bottom of carb, not easy to inspect or see.

Action: Drill and tap, replacing with threaded set screw or hex head bolt (and safety wired).
